Extension Pins and Log Load Securing Requirements

NOGGIN INC2682 10/08/20 – Medical Treatment Injury.

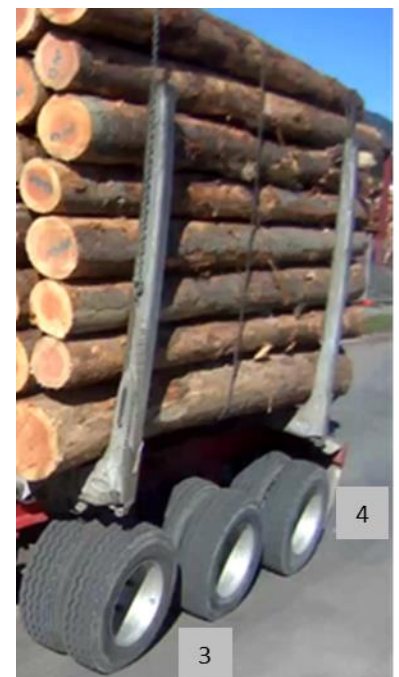
Description – while unchaining the load a driver released the tension on the chains before proceeding to the passenger side of the trailer to hang them up. CCTV footage shows the driver stowing the chain at bolster 4 before moving forward to bolster 3 when the top-log (as pictured) rolled off the bunk. It struck the driver on the shoulder and side of the head, causing minor cuts and heavy bruising.

NOTE: The image is taken as the truck arrives at the Port, as captured by security camera. The extension pin is visible on bolster 4 but not visible on bolster 3, however it was not lowered by the driver. The log that fell is the top-most log pictured in the image. As situated, it is sitting on top of the ‘outside log’ – please compare with the log loading graphic.

The truck was fitted with Patchell bolsters, specifically engineered and time proven. However, the investigation revealed that the extension pins were retrofitted by the original owner of the vehicle, and someone other than Patchells. **Incorrect installation** has allowed the pin to extend beyond its design limit and therefore not lock into place correctly. It has subsequently dropped down into the bolster, at some time during transit.

1. When using new or used equipment both Owners and Operators have duties to ensure that devices are properly installed, can activate or lock-out correctly, and be used safely.
2. PCBU’s that design, manufacture, import, supply and install plant, substances, or structures must ensure such are safe to use and fit for purpose – [HSW Act 2015 s. 36–43](#).
3. Immediately report faulty equipment taking it out of service until corrected or repaired.
4. Use this alert as an occasion to review all safety devices **especially on extension pins**.

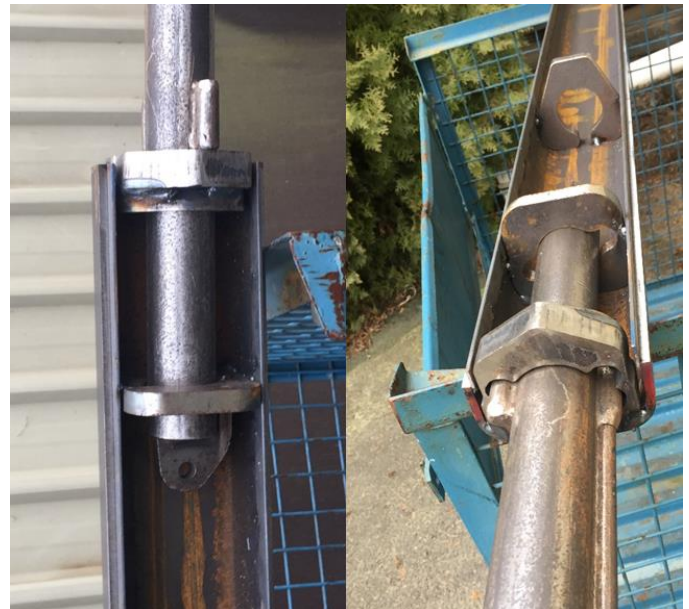
The Patchell ‘extension pin design is robust and sturdy and will perform as intended if fitted according to the manufacturer’s plans – this one was not!

- **Experienced drivers** tell us that using an incorrectly fitted pin, such as the one in this incident, would give a sense (feel) of having the ‘wrong key in the lock’.
- Logs must be loaded according to the **ACOP standards** – no exceptions. Carting a lighter species of logs e.g. Douglas Fir, is not an excuse for overloading or poor loading.
